War on Hail: The Impact of Hail

Tanya M. Brown, Ph.D.
Insurance Institute for Business & Home Safety

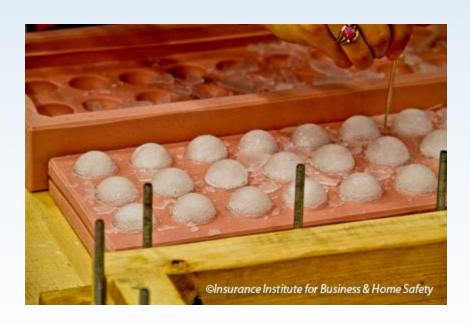
Chemical—Tap Water, Distilled Water, Seltzer Water

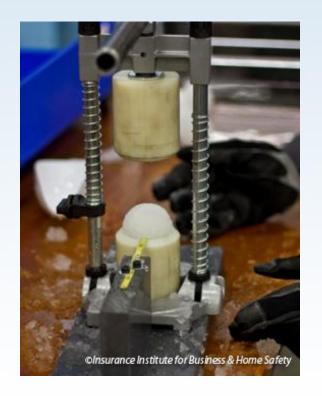
Physical—Compacted Crushed Ice

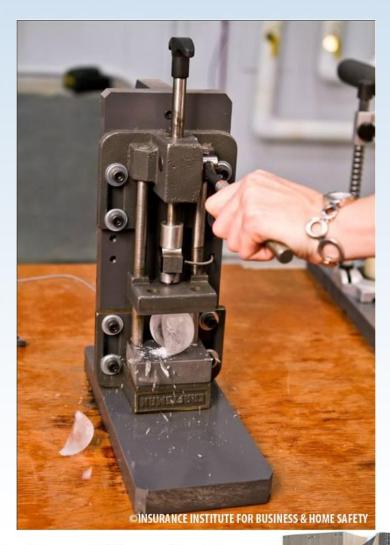
Density

- Artificial Hailstones: 0.45-1.1 g/cm³
- Natural Hailstones: 0.1-0.9 g/cm³

Hardness

- Artificial Hailstones: 3-308 psi
- Natural Hailstones: 9-620 psi

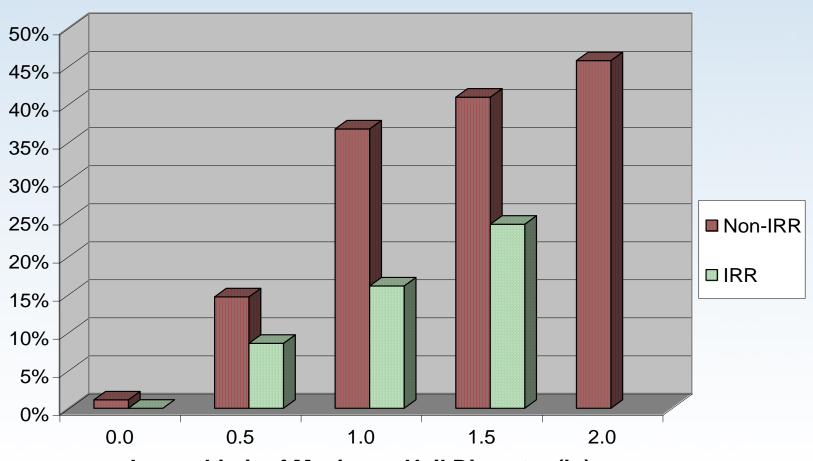
Percent of Policies with Losses (Indemnity Paid > \$1)

Lower Limit of Maximum Hail Diameter (in)

Asphalt shingles

- 99.65% non-IR
- \$5,200 average damage
- 3.1% damage-tocoverage ratio

Asphalt IR Shingles

- 0.35% IR
- \$4,400 average damage
- 1.9% damage-tocoverage ratio

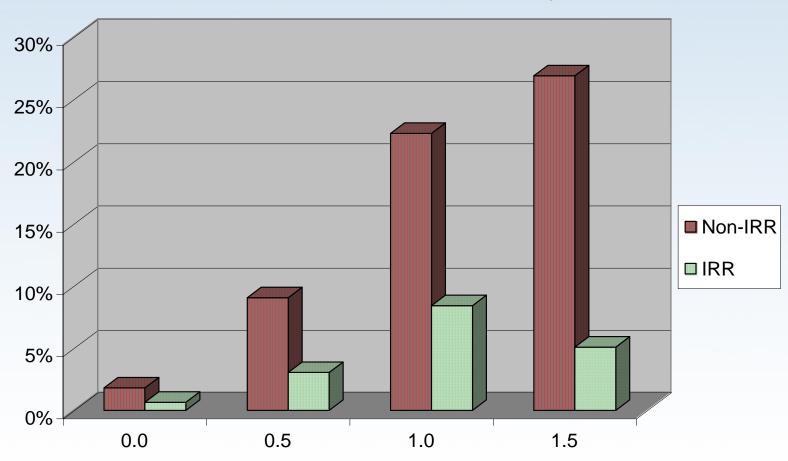
Percent of Policies with Losses (Indemnity Paid > \$1)

Lower Limit of Maximum Hail Diameter (in)

Metal Roofs

- 69% non-IR
- \$11,000 average damage
- 11% damage-tocoverage ratio

Metal IR Roofs

- 31% IR
- \$21,000 average damage
- 5.8% damage-tocoverage ratio
